TOKAT – RESTORATION OF THE CARAVANSARAY OF PAZAR MAHPERI HATUN

Serdar Kasap¹, Başak Zengin²

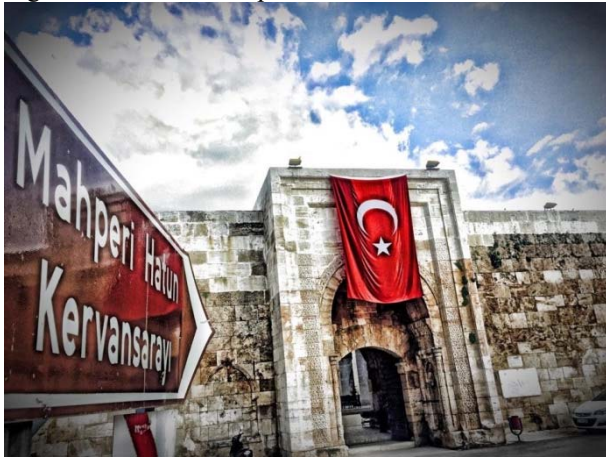
Picture -1. Tokat / Pazar Mahperi Hatun Caravanserai

Established on the Amasya-Tokat road, 1 km east from the district Pazar, near the Yeşilirmak River; according to two inscriptions the "public house" has been built by Sultan Melike Mahperi Hatun and was finished in the year 636/ 1238-39. (Picture-1). Hall 19.50x28 m (10 stone pedestals), the court is 33x34 m big (Özerkin,1965). Figure 2 shows the site plan of the caravanserai.

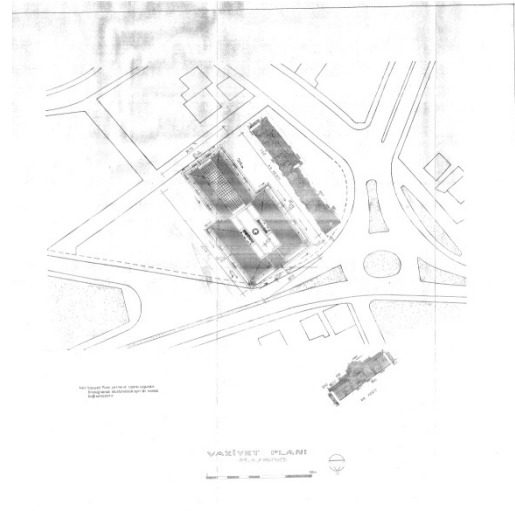
Figure 2: Pazar / Tokat Mahperi Hatun Caravanserai Site Plan

The caravanserai consists of two different sections, one summer and one winter section. The summer section consists of a cloister that is surrounding the court and the parts behind it. The winter section however is divided into three parts by two rows of pillars, the pendentive is covered and completely closed to the outside. The caravanserai consists of cut stones and is rectangular planned. The entrance door is very pompous, has a rectangular shape and stands inside a pointed arched niche. There is a construction inscription above the entrance door. The door inside the niche stands inside a round arch and consists of alternatively different colored stones. It resembles the portals of Anatolian Seljukian madrasahs and caravanserais. The roof of the caravanserai is completely destroyed but the portal and outer walls survived in a good condition until today (www.e-tatih.org,2015).

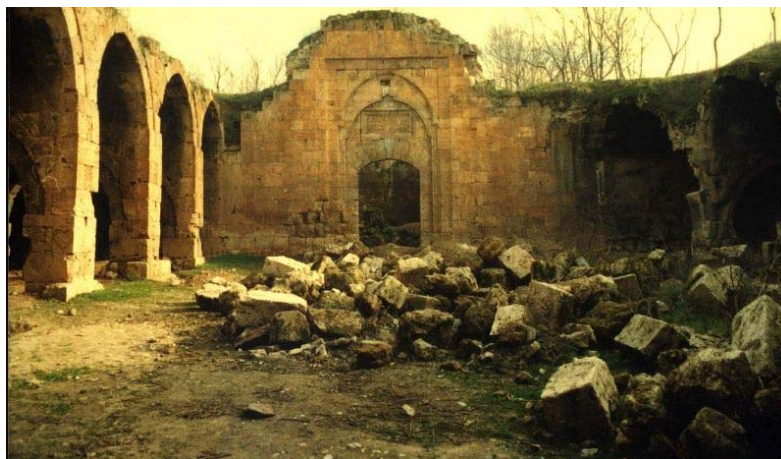
Picture-6; Tokat - Pazar Mahperi Hatun Caravanserai Open Inner Court (Foundations General Directorate-Tokat District Directorate)

Like seen in the building survey of the Mahperi Hatun Caravanserai, the bearing stands of the pendentive arches on the right and left of the court have become extremely damaged over the years (Picture 6).

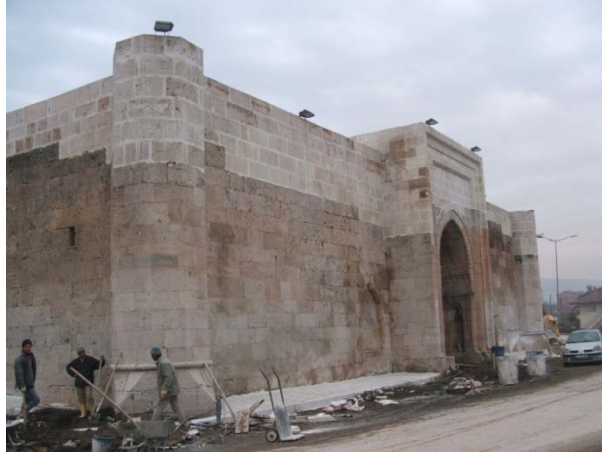
Picture-7; Tokat - Pazar Mahperi Hatun Caravanserai Open Outer Walls (Foundations General Directorate-Tokat District Directorate)

The bearing walls of the Mahperi Hatun Caravanserai was built with cut stones. The bearing walls, which make up a big part of the outer periphery of the structure was preserved in its original form and was only cleaned up. Walls with missing or insufficient parts were restored according to the building survey. Appropriate stones that fit the texture of the structure were supplied by the quarry in the center of Tokat and by manufacturing them properly the loads provided by the structure were transmitted to the basis (Picture-7). To ensure integrity of the wall, stones were connected with mortar, seam and wood/wrought iron beams on different levels. Some parts of the wall were strengthened with struts so they would withstand the loads from the oblique roof.

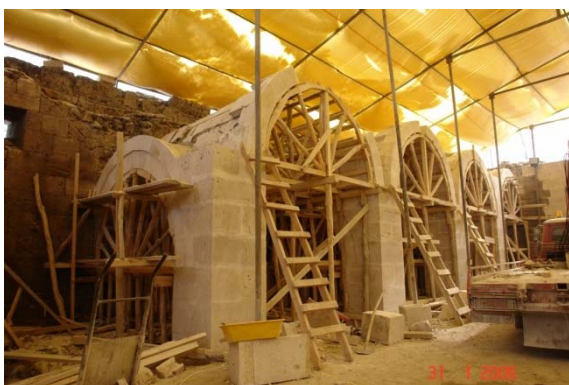
Picture- 8; Tokat - Pazar Mahperi Hatun Caravanserai Closed Court Pendentive Manufacture

In the Mahperi Hatun Caravanserai part of the pendentives in the open court and all of the pendentives in the closed area were damaged or collapsed. The pendentives were manufactured by creating supporting molds and they were strengthened with adhesive mortar and wrought iron beams (Picture-8, Picture-9).

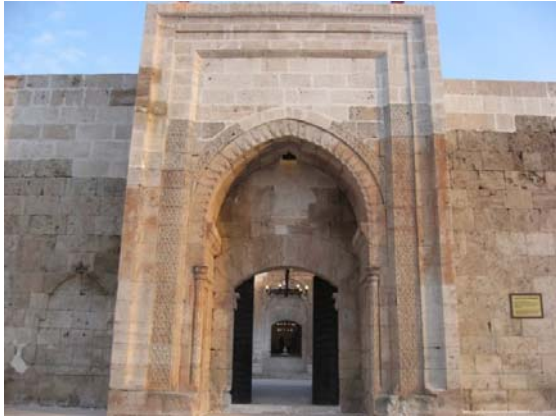
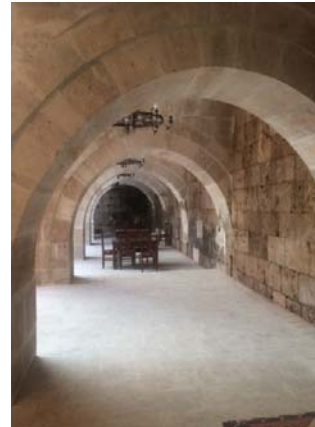
Arches are architectural elements that are connected to a semicircle or arc-shaped center lock stone, rise up on two feet on which they bear the weight of the upper wall and create an opening with the desired space. The arches here are used as junction points between the pendentive feet and the outer walls of the structure and are located above the main entrance of the structure, the entrance of the open court and the door between the open and closed court (Picture-10/Picture-11). Because they were generally in a better shape than the pendentives, simple refuting and

stones in bad shape were switched out and the transfer of the dome load to the main wall, which is their main task, was made safer.

Picture-10; Tokat - General View of the Pazar Mahperi Hatun Caravanserai Main Entrance Door

Picture-11; Tokat - General View of the Pazar Mahperi Hatun Caravanserai Pendentive Arches

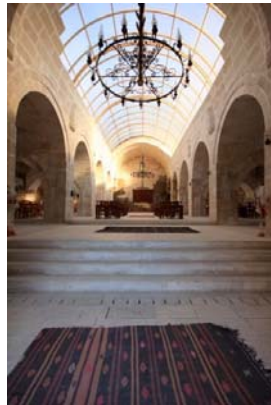
Picture-12; Tokat - Pazar Mahperi Hatun Caravanserai Height Difference of the Open and Closed Court

By using part of the surviving wall of the closed court, the location and height of the present windows could be calculated (Picture – 12). Because of the height difference of the closed and open court, a concrete floor and stairs were created (Picture – 13).

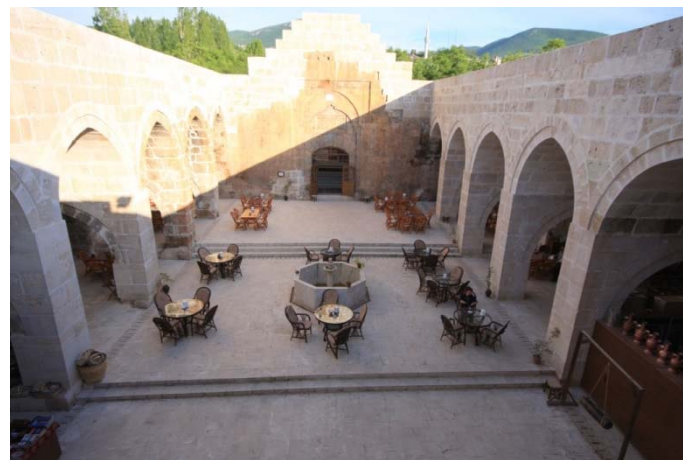
Picture-13; Tokat - Pazar Mahperi Hatun Caravanserai Inner Pavement Application

As the inner court of the structure was in better shape than the closed court, application decisions were taken more easily in line with the restitution project. Surviving pendentive ruins were saved and completed with appropriate stone material. Completely destroyed pendentives however were rebuilt in line with the restitution project. The structure system and ruins revealed, that the pavement is made out of stones. Thus the height differences of the structure were evened out with concrete and covered with stones (Picture-13).

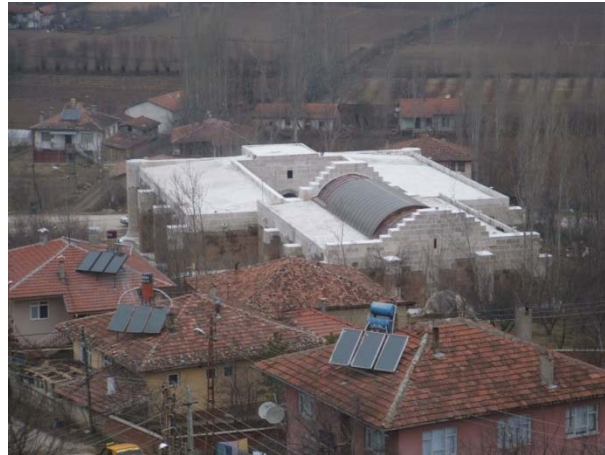
Picture-14; Tokat - General View of the Pazar Mahperi Hatun Caravanserai

By evaluating the ruins of the Mahperi Hatun Caravanserai and the obtained documents, a restoration project was prepared in line with the prepared restitution project. The stone basis of the building was present and by cleaning up the ruins it was strengthened with appropriate brickdust mortar and cut stones with the same properties of the original material. Present walls of the caravanserai however were numbered, removed and put aside about to be masoned again. Usable stones were separated and insufficient material was substituted with appropriate material by the quarry in the center of Tokat in order to mason the walls (Picture-14). Missing pieces were replaced by new material with the same properties. Since some gutters were in good shape they were used again. Because no wood material was left, new elements were manufactured according to the project.

After placing stone blocks for regional repairs of regional/local cracks, the gaps were filled with an appropriate mortar injection. For the repair of fine cracks and cracks and gaps in thick walls the best method is to use a mortar injection with similar properties of the wall. Instead of the renewal of some elements, present elements were repaired and stainless steel was placed in the junction points.

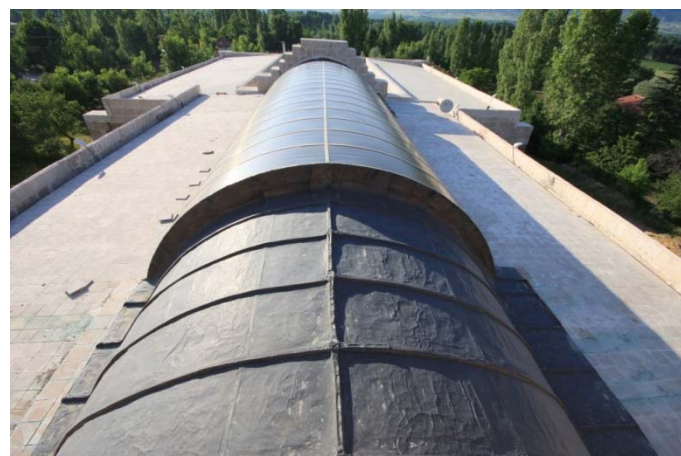
Picture-15; Tokat - General View of the Pazar Mahperi Hatun Caravanserai Roof

Different from the original structure both parts (Inner court and closed court), the floor and the roof were isolated and protected against water. First the top of the pendentives were filled with light material and the whole structure was covered with stone pavement. The top of the closed court however was covered with polycarbonate material, so it doesn't lie heavy on the structure, and the arched iwan part was covered with lead material. Considering snow and rain falling on the structure, the stone pavement was created beveled and with gutters the water drain was ensured. The Roof Surface of the Mahperi Hatun Caravanserai (Picture-15).
